## Low-Pressure Plasma; An Alternative Method of Cleaning Historical Silver Coins

Cold plasma treatment is a green technology for cleaning and surface decontamination in various applications. The work in the present paper discusses the use of high-frequency cold plasma for the removal of corrosion products and surface deposits from historical silver coins. The coins, conserved by the Cultural Heritage Organization of Iran, are of the Parthian period and are of significant historical and cultural value. Cold plasma is non-invasive in nature and efficient, with various advantages over traditional cleaning methods. In an attempt to quantify the elemental composition of the coin surfaces, X-ray fluorescence (XRF), scanning electron microscopy (SEM), and energy-dispersive X-ray spectroscopy (EDAX) were performed. The success of the treatment using the plasma was later analyzed by gravimetry, optical microscopy, and comparative imagery. The results indicated a significant reduction in the surface deposits, as confirmed by the measurements of the weights as well as by the microscope. The before-and-after imagery also indicated the improvement in the clarity of the coin designs, which wer

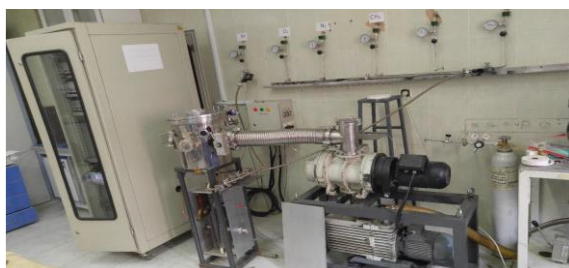
**Fig.2.** The PECVD device used for conducting the experiments.

Because the samples were highly sensitive to the temperature, in this study cold plasma under vacuum with RF power supply was employed. The device was configured to run at a frequency of 13.56 MHz with process parameters of 100 W applied power at 20 mTorr, and a total gas flow rate of 30 SCCM. Plasma processing device image shown in figure 2. Based on the type of gas used, the duration of treatment was modified (90 min Ar/O<sub>2</sub>, 60 min Ar/H<sub>2</sub>)

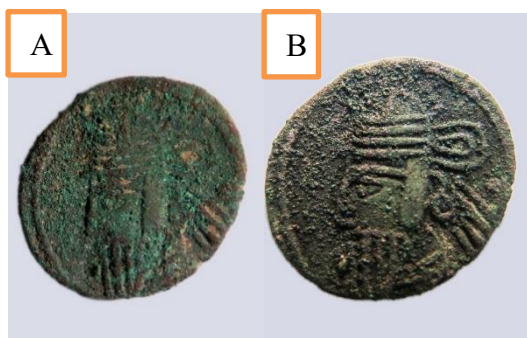
**Fig.5.** Figures a and b before and after plasma treatment for sample C8

The green coloration observed in the images (Figures 5A and 6A) likely indicates the presence of malachite ( $\text{Cu}_2(\text{OH})_2\text{CO}_3$ ) and copper hydroxide chloride ( $\text{Cu}_2(\text{OH})_3\text{Cl}$ ) on the surface. Additionally, the reddish-brown hue is most likely due to cuprite ( $\text{Cu}_2\text{O}$ ), suggesting oxidation and corrosion processes affecting the coins.

In Figure 5B, a comparison with image A shows that malachite, copper hydroxide chloride, and reddish-brown corrosion layers have been largely removed. This cleaning process has enhanced the clarity of engraved patterns on the coin. For instance, finer details, such as the helmet and the king's eye, have become more distinguishable, demonstrating the effectiveness of plasma treatment in removing deposits and improving the coin's readability.

The green and blue coloration observed in Figures 5 and 6 most likely indicates the presence of malachite ( $\text{Cu}_2(\text{OH})_2\text{CO}_3$ ) or azurite ( $\text{Cu}_3(\text{CO}_3)_2(\text{OH})_2$ ). These compounds are common corrosion products in copper-silver coins, forming in humid or salt-rich environments, which accelerate the corrosion process.

Following cold plasma treatment under vacuum using  $\text{Ar}/\text{O}_2$  or  $\text{Ar}/\text{H}_2$  gases, portions of the corrosion layers were successfully removed, revealing finer details of the engravings. However, as shown in images B of Figures 5 and

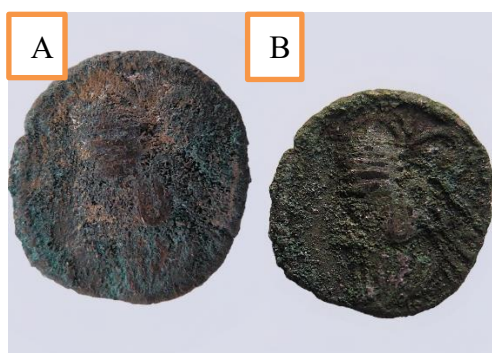
**Fig.6.** Figures a and b before and after plasma treatment for sample C8

Figure 6 presents images of sample C24 before (A) and after (B) plasma treatment. In image A, the presence of copper oxides ( $\text{Cu}_2\text{O}$ ,  $\text{CuO}$ ), copper chlorides ( $\text{CuCl}$ ,  $\text{CuCl}_2$ ), and copper carbonates is evident, corroborating the EDAX and XRF data, which detected high levels of oxygen and foreign elements in the surface composition.
