**Research paper****Low-Pressure Plasma; An Alternative Method of Cleaning Historical Silver Coins**

Cold plasma treatment is a green technology for cleaning and surface decontamination in various applications. The work in the present paper discusses the use of high-frequency cold plasma for the removal of corrosion products and surface deposits from historical silver coins. The coins, conserved by the Cultural Heritage Organization of Iran, are of the Parthian period and are of significant historical and cultural value. Cold plasma is non-invasive in nature and efficient, with various advantages over traditional cleaning methods. In an attempt to quantify the elemental composition of the coin surfaces, X-ray fluorescence (XRF), scanning electron microscopy (SEM), and energy-dispersive X-ray spectroscopy (EDAX) were performed. The success of the treatment using the plasma was later analyzed by gravimetry, optical microscopy, and comparative imagery. The results indicated a significant reduction in the surface deposits, as confirmed by the measurements of the weights as well as by the microscope. The before-and-after imagery also indicated the improvement in the clarity of the coin

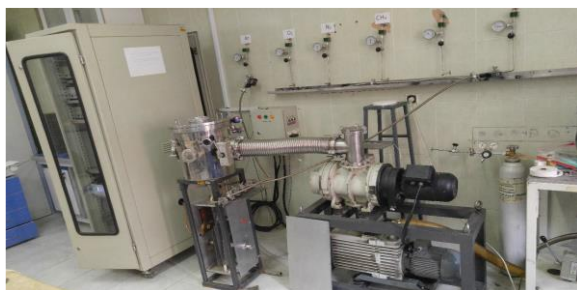
**Fig.2.** The PECVD device used for conducting the experiments.

Because the samples were highly sensitive to the temperature, in this study cold plasma under vacuum with RF power supply was employed. The device was configured to run at a frequency of 13.56 MHz with process parameters of 100 W applied power at 20 mTorr, and a total gas flow rate of 30 SCCM. Plasma processing device image shown in figure 2. Based on the type of gas used, the duration of treatment was modified (90 min Ar/O<sub>2</sub>, 60 min Ar/H<sub>2</sub>)

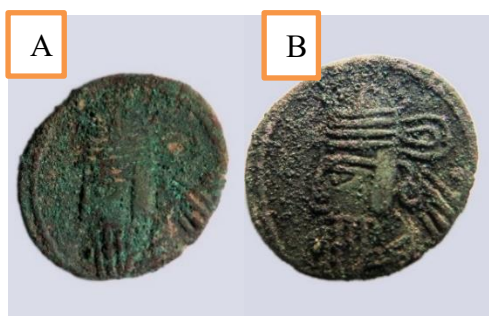
**Fig.5.** Figures a and b before and after plasma treatment for sample C8

The green coloration observed in the images (Figures 5A and 6A) likely indicates the presence of malachite ( $\text{Cu}_2(\text{OH})_2\text{CO}_3$ ) and copper hydroxide chloride ( $\text{Cu}_2(\text{OH})_3\text{Cl}$ ) on the surface. Additionally, the reddish-brown hue is most likely due to cuprite ( $\text{Cu}_2\text{O}$ ), suggesting oxidation and corrosion processes affecting the coins.

In Figure 5B, a comparison with image A shows that malachite, copper hydroxide chloride, and reddish-brown corrosion layers have been largely removed. This cleaning process has enhanced the clarity of engraved patterns on the coin. For instance, finer details, such as the helmet and the king's eye, have become more distinguishable, demonstrating the effectiveness of plasma treatment in removing deposits and improving the coin's readability.

The green and blue coloration observed in Figures 5 and 6 most likely indicates the presence of malachite ( $\text{Cu}_2(\text{OH})_2\text{CO}_3$ ) or azurite ( $\text{Cu}_3(\text{CO}_3)_2(\text{OH})_2$ ). These compounds are common corrosion products in copper-silver coins, forming in humid or salt-rich environments, which accelerate the corrosion process.

Following cold plasma treatment under vacuum using  $\text{Ar}/\text{O}_2$  or  $\text{Ar}/\text{H}_2$  gases, portions of the corrosion layers were successfully removed,

revealing finer details of the engravings. However, as shown in images B of Figures 5 and 6, while the plasma treatment effectively reduced the oxide and corrosion layers, some residues remain on the coin's surface

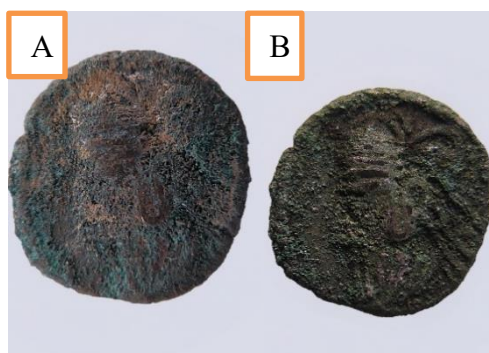
**Fig.6.** Figures a and b before and after plasma treatment for sample C8

Figure 6 presents images of sample C24 before (A) and after (B) plasma treatment. In image A, the presence of copper oxides ( $\text{Cu}_2\text{O}$ ,  $\text{CuO}$ ), copper chlorides ( $\text{CuCl}$ ,  $\text{CuCl}_2$ ), and copper carbonates is evident, corroborating the EDAX and XRF data, which detected high levels of oxygen and foreign elements in the surface composition.
